Portage Creek Sediment Remediation Project Kalamazoo, Michigan

Pre-Sediment Removal Structure Feature Assessment Removal Area SA6

F&V Project Number: 809930
April, 2012

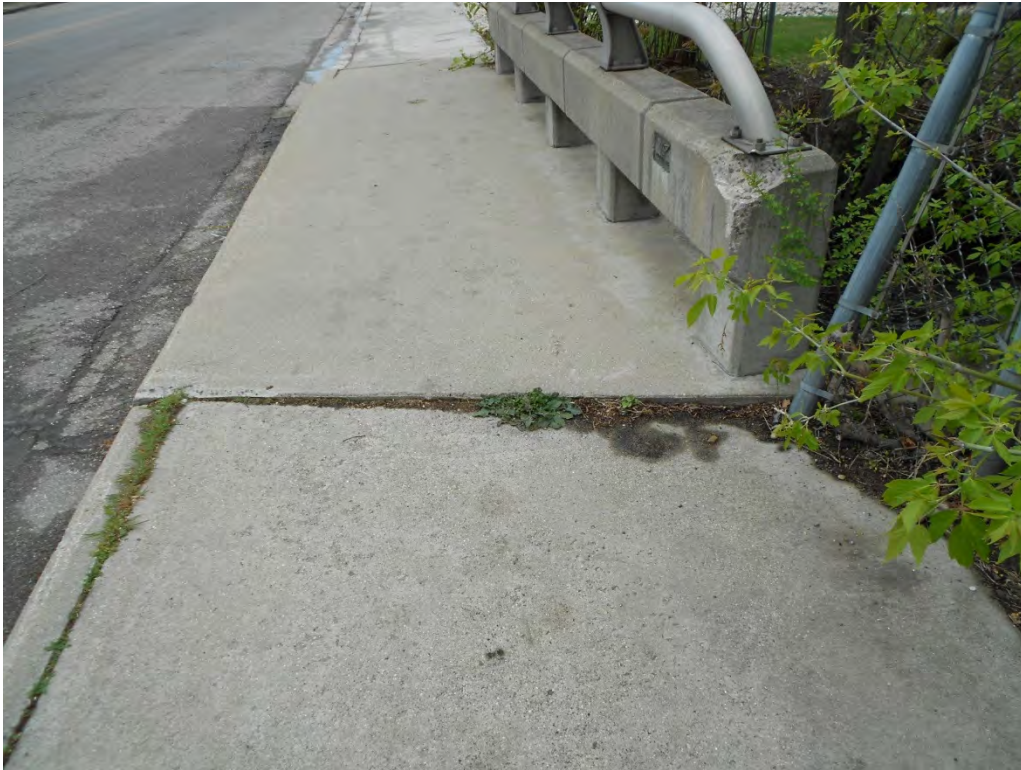
- The asphalt surface has moderate transverse cracking along the reference lines and ~3 lines of moderate longitudinal cracking.
- The northwest approach sidewalk has settled ~1-1.5" at the reference line. The northeast sidewalk has settled ~1.5-2" at the reference line. The sidewalk in the southwest is newer.

Settlement of sidewalk in the northeast

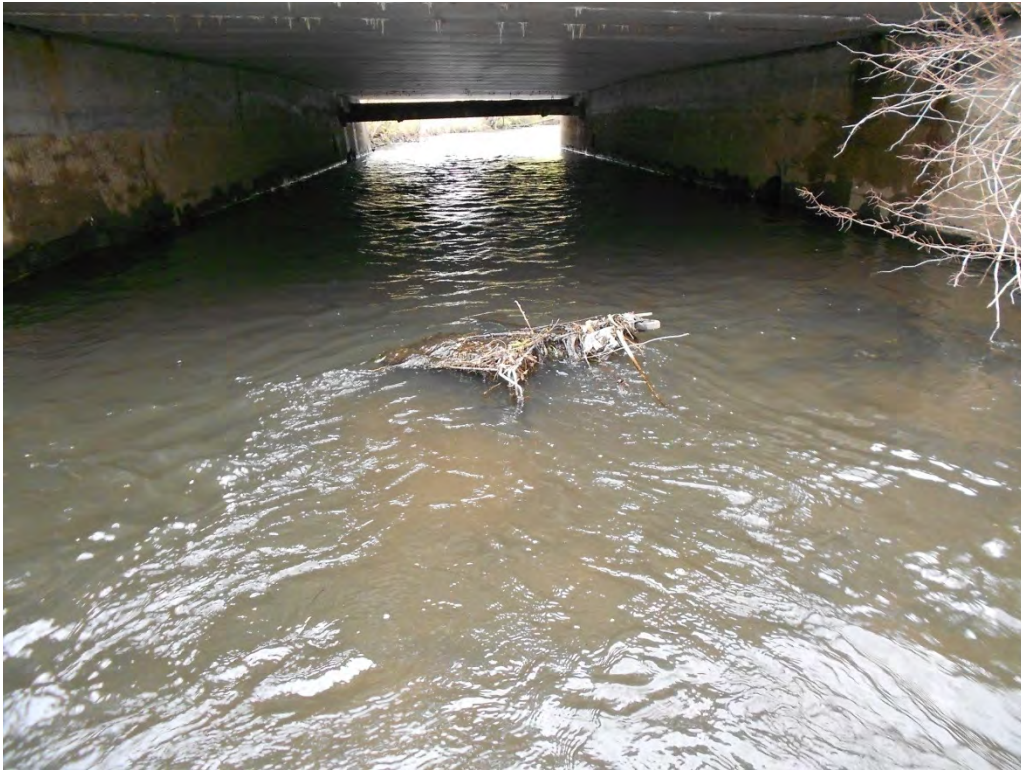
Trash in the channel area

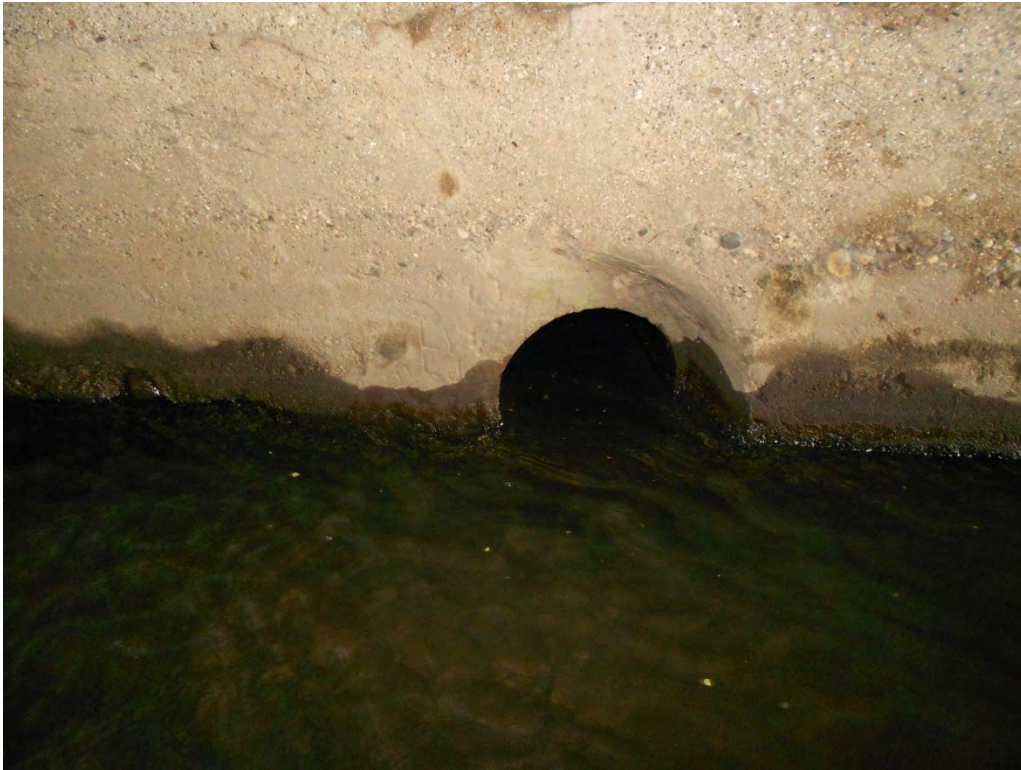
Culvert outlet through abutment at waterline

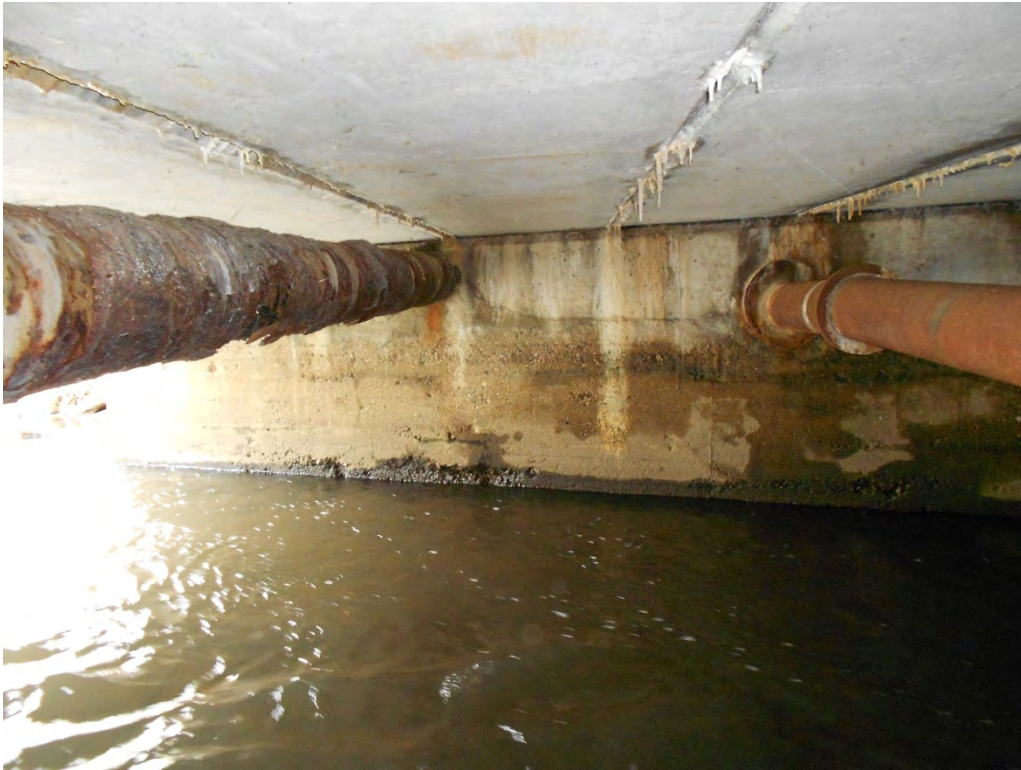
- The northeast abutment is severely spalled and abraded at the waterline. The abutments have moderate abrasion along the waterline throughout.
- Heavy leakage with efflorescence and stalactites was noted on box beam joints 1N, 2N and 1-5S.

- There are 2 utilities crossing the creek beneath the south side of the structure through the abutment walls. The northern pipe has moderate surface corrosion. The southern pipe has heavy surface corrosion and scale with minor to moderate section loss, especially on the bottom.

Utility crossings and stalactites along box beam joints

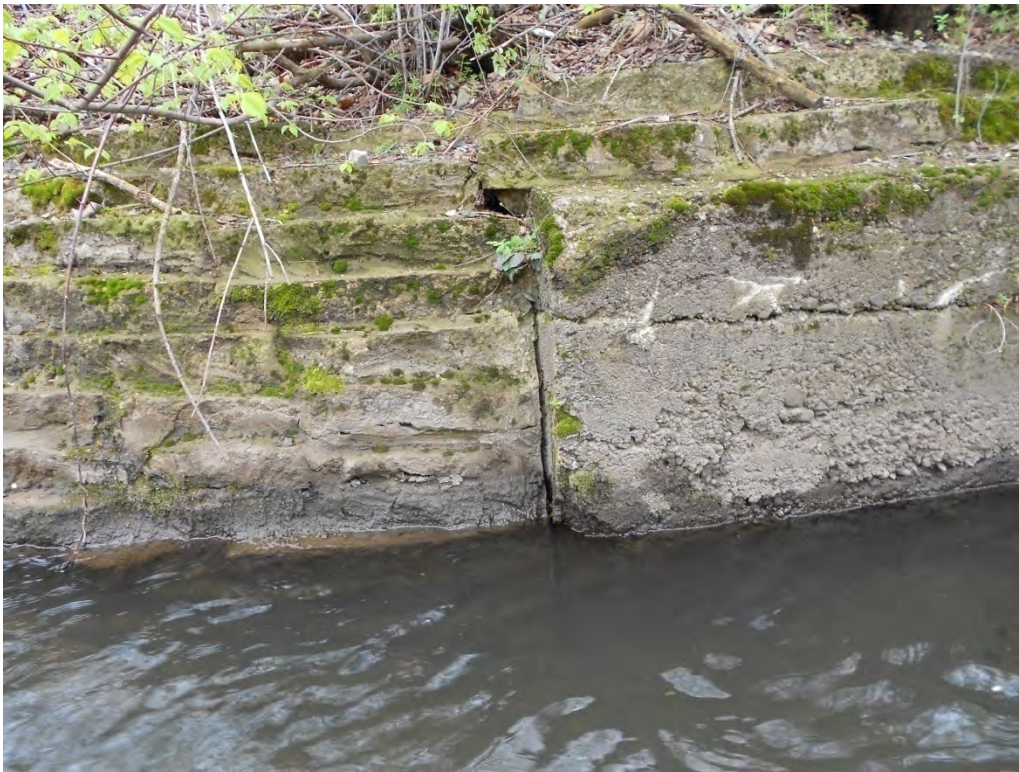
Gap between northeast wingwall and extension

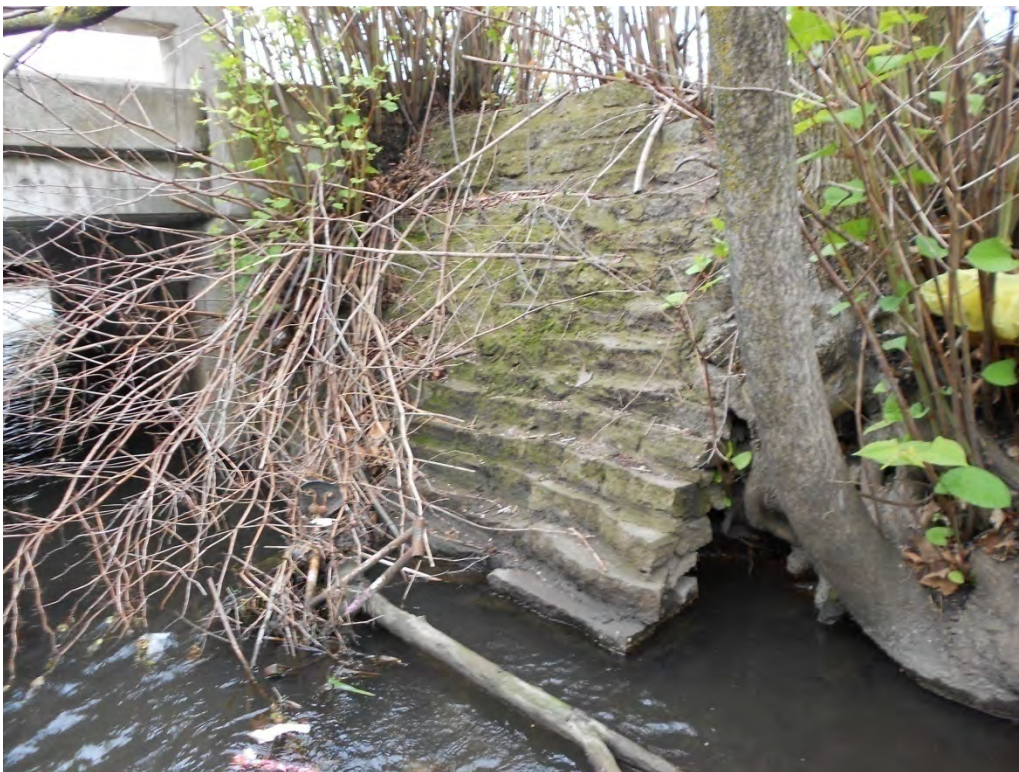
Bank erosion and undermining around northwest wingwall extension

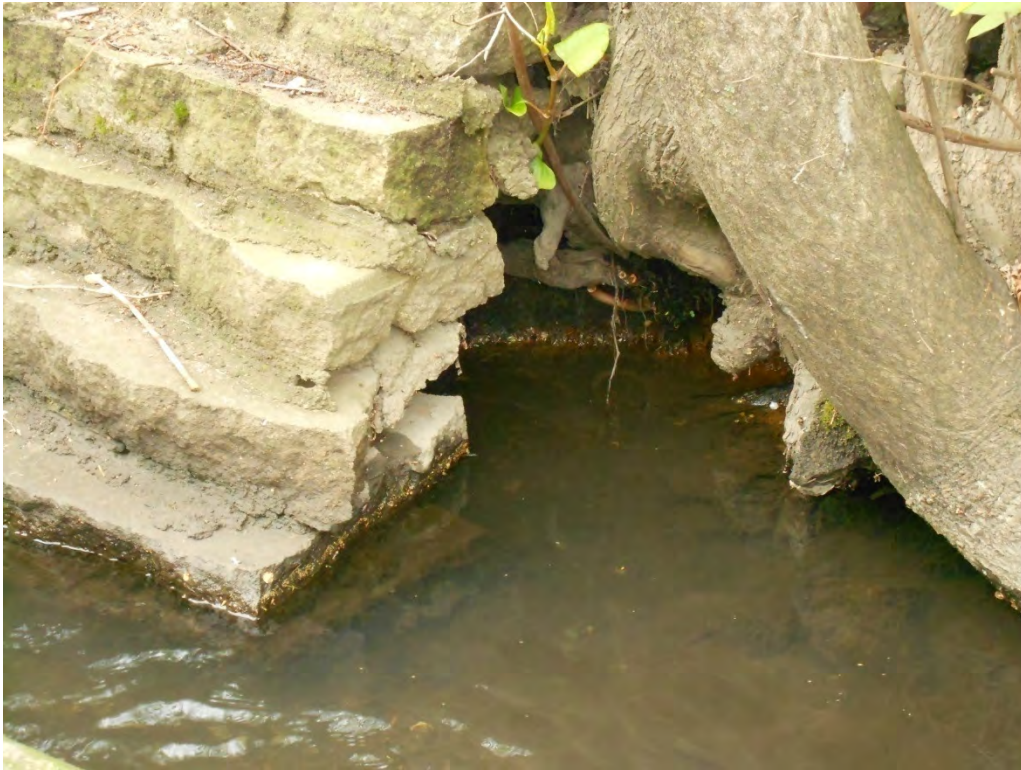
Close-up of undermining at northwest wingwall extension

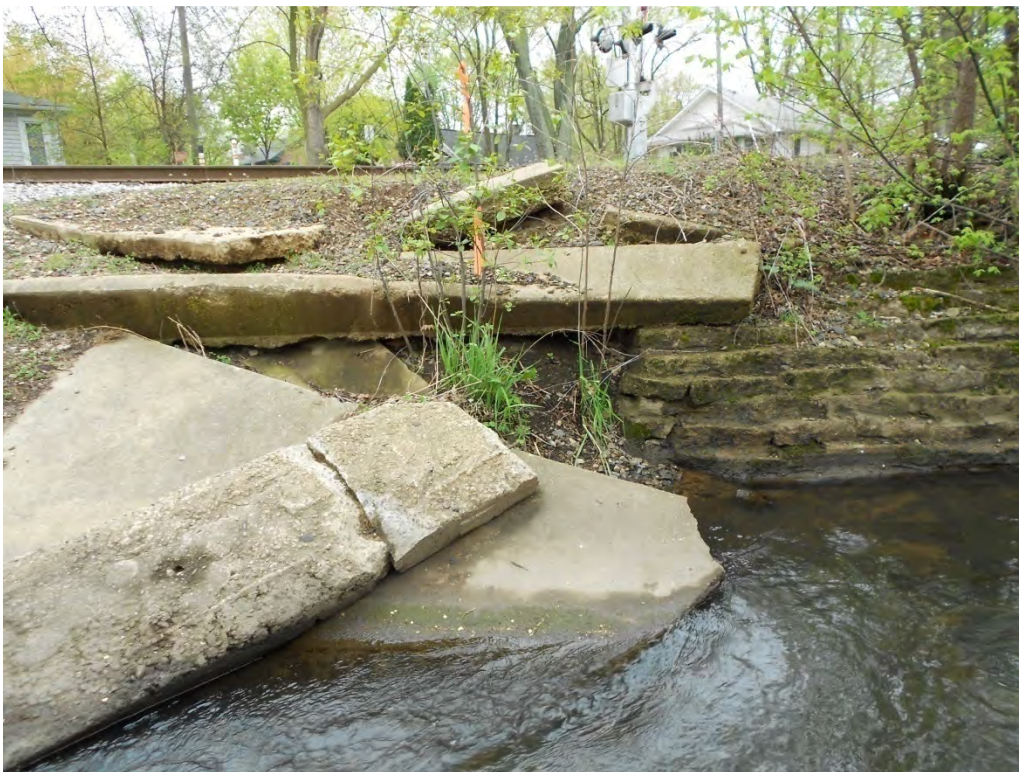
- Several of the slabs are cracked and spalled.
- Most of the slabs are undermined to some degree.

View of the slabs adjacent to the northeast wingwall extension of the Stockbridge Bridge

- Remove the slabs as needed to facilitate sediment removal and replace them in kind as directed by the City of Kalamazoo.

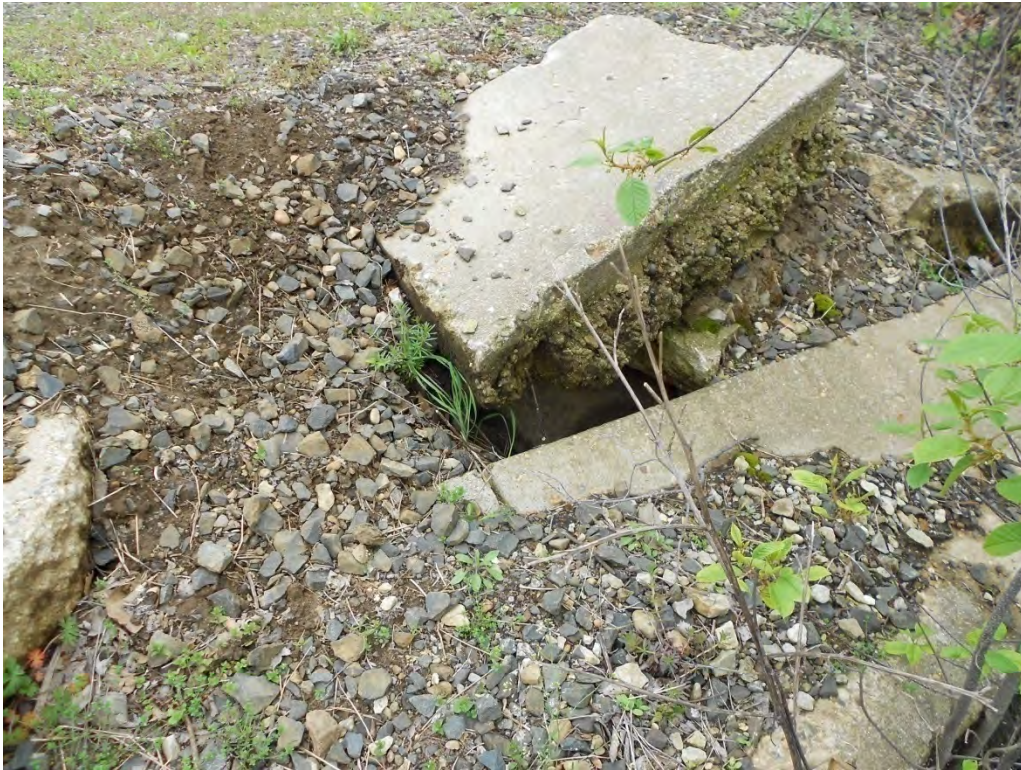
Undermining around concrete slabs

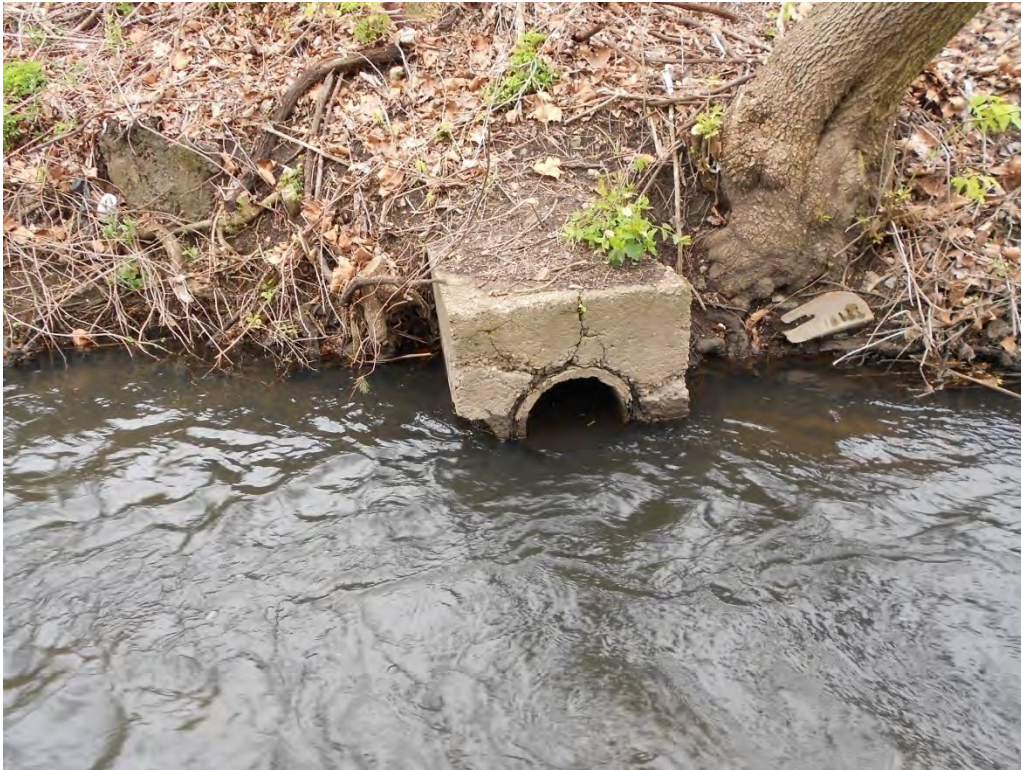
- The concrete headwall is severely abraded and cracked. The upstream lower corner has spalled off.
- The exposed end of the clay tile is spalled.
- The channel is approximately 8 inches below the invert of the pipe, but no undermining was noted.
- The bank has eroded approximately 2.5 feet around the headwall.

View of the outlet from the channel

- Because SA6-S04 is located in an area not planned for dewatering, a cofferdam is not anticipated to be required. To prevent undermining of the outlet, avoid sediment removal in the immediate area of the outlet, leaving approximately 4 feet of clearance.

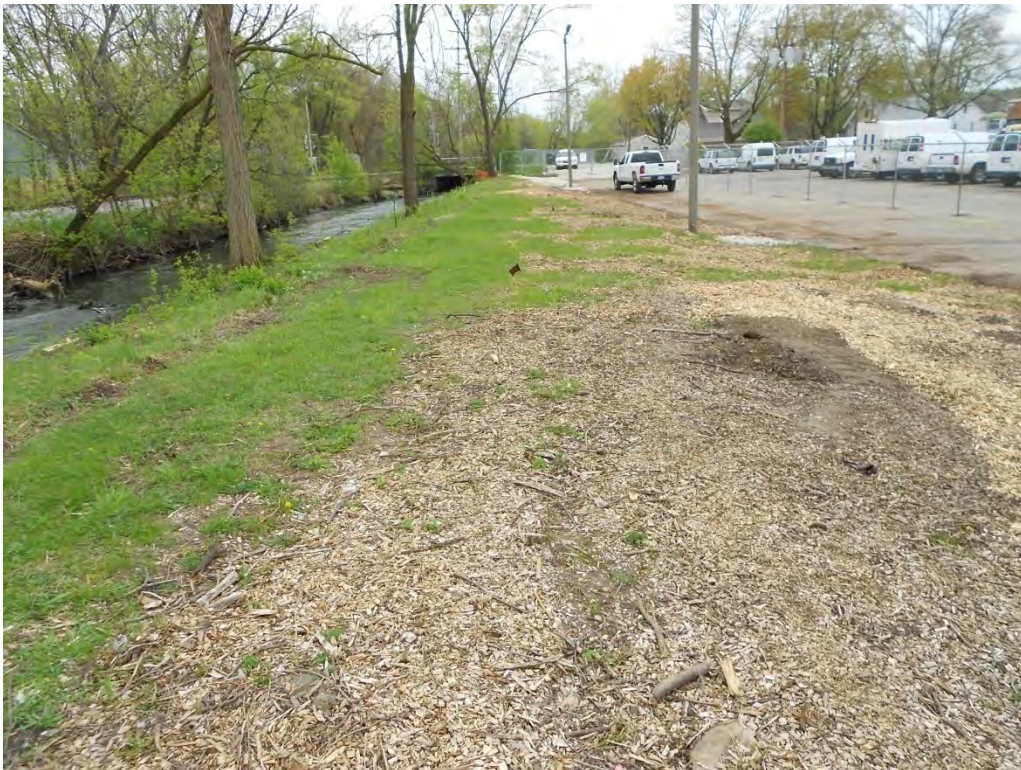
Location flagging along the west bank where the sewer is parallel to the creek

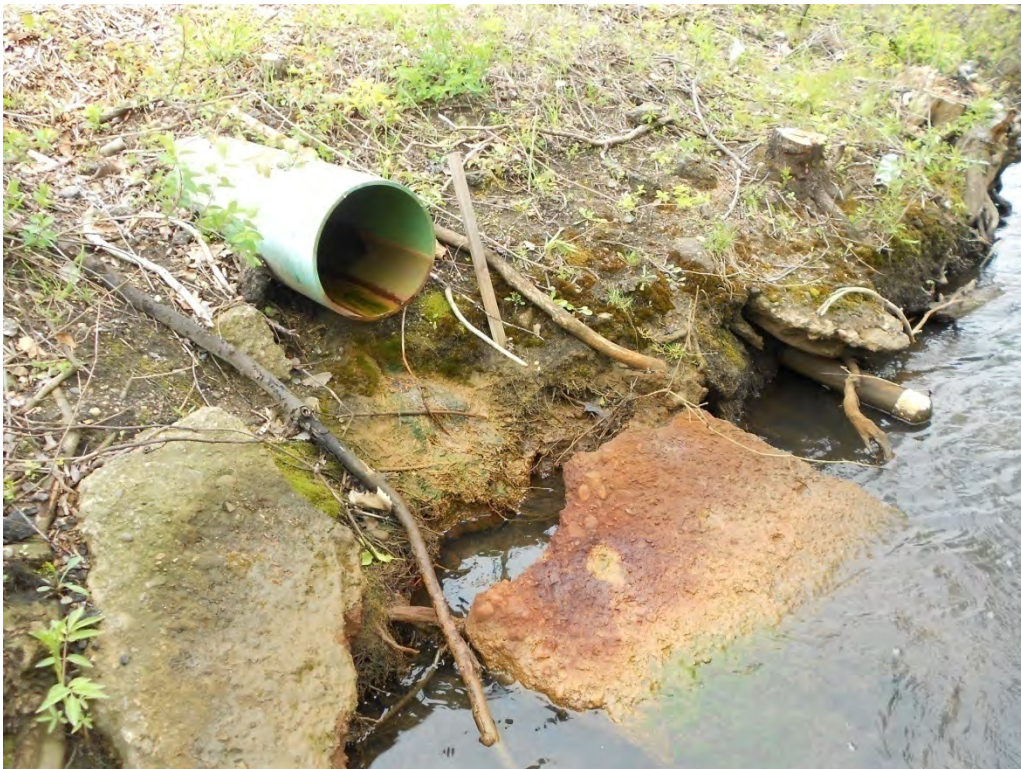
View of the outlet from the upstream bank area

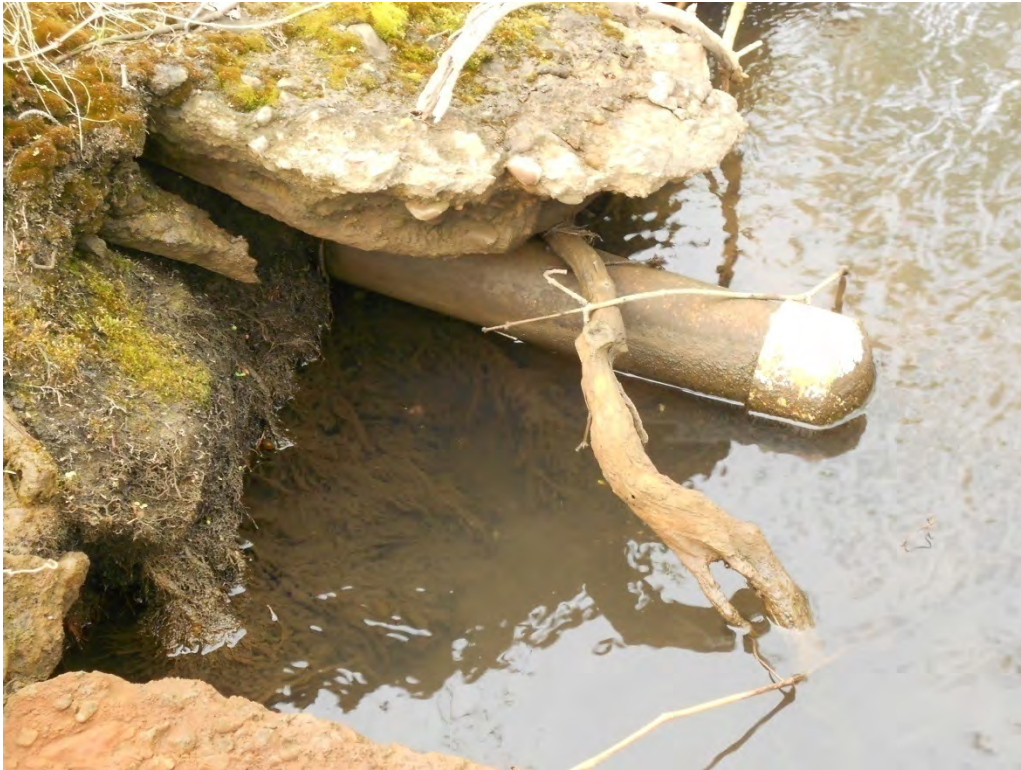
Close-up of the smaller capped outlet

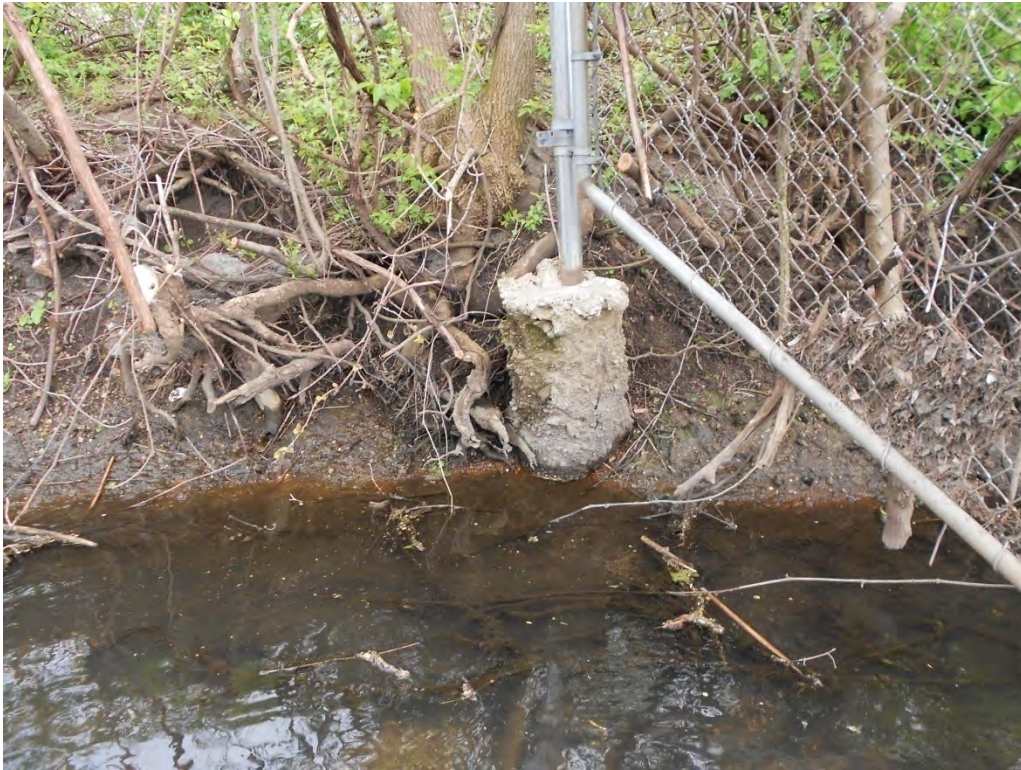
Close-up of the concrete base exposed by bank erosion

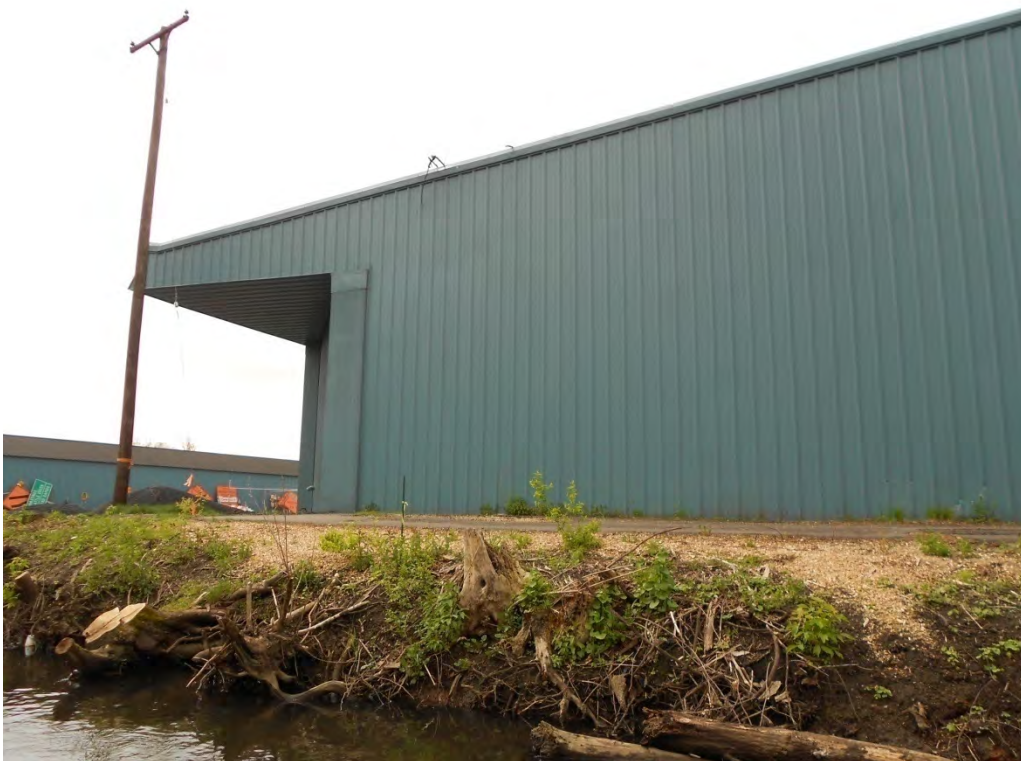
South end of the building viewed from the channel

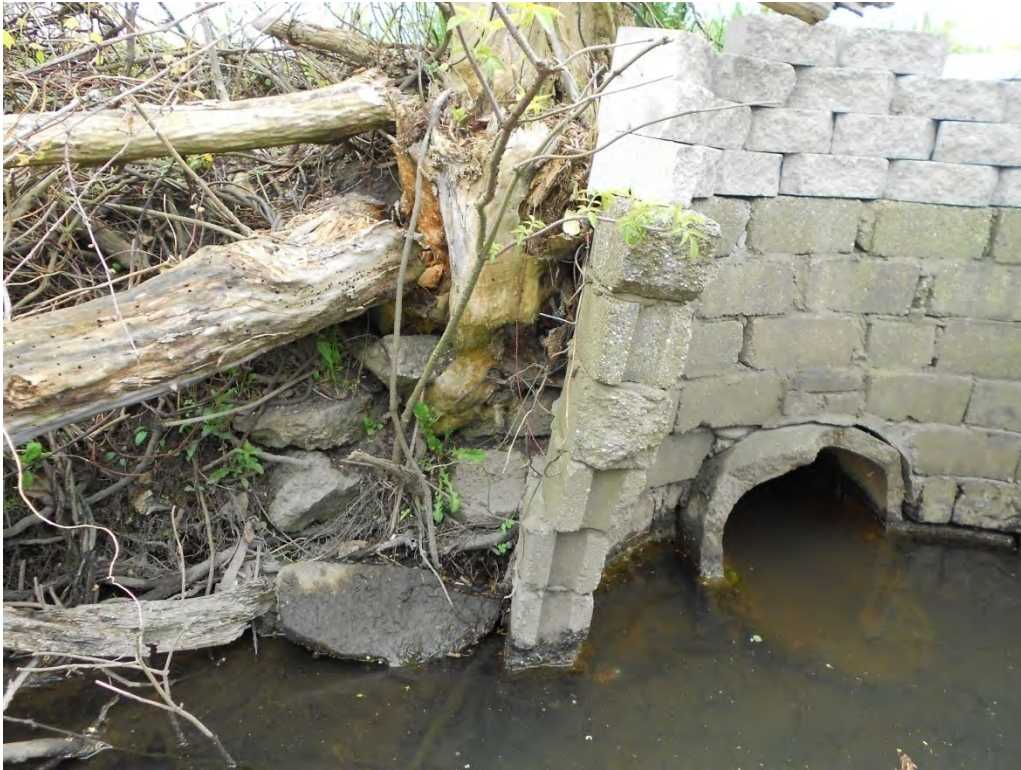
Severe leaning of north side of headwall with root growth behind

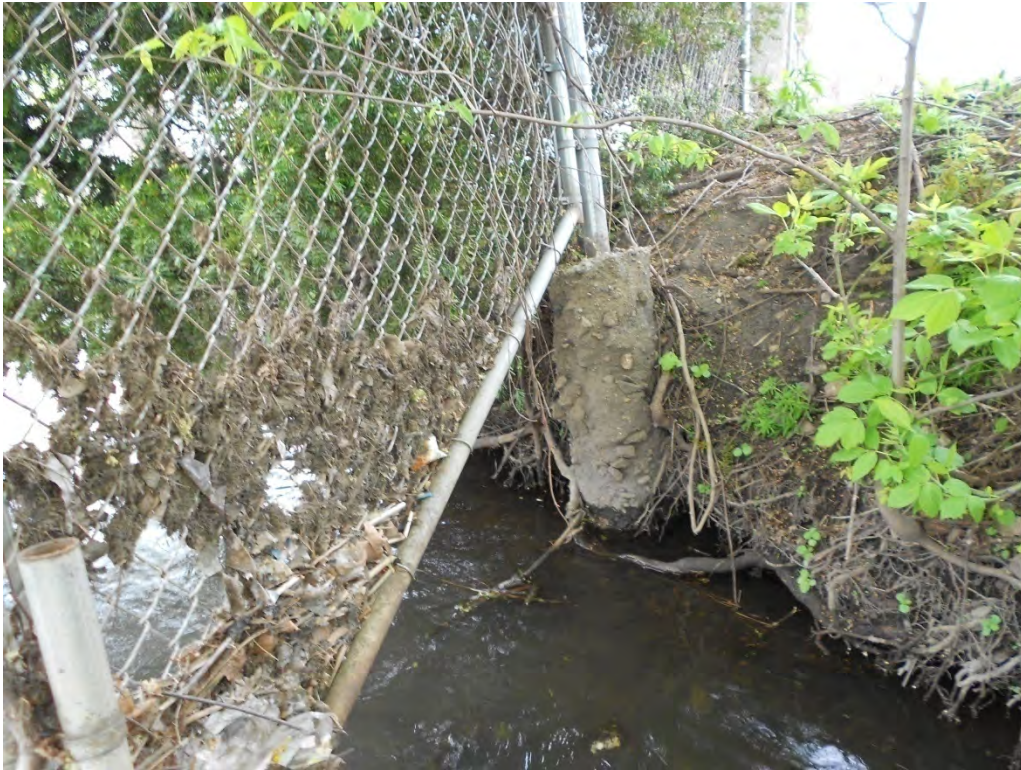
Concrete base exposed by bank erosion

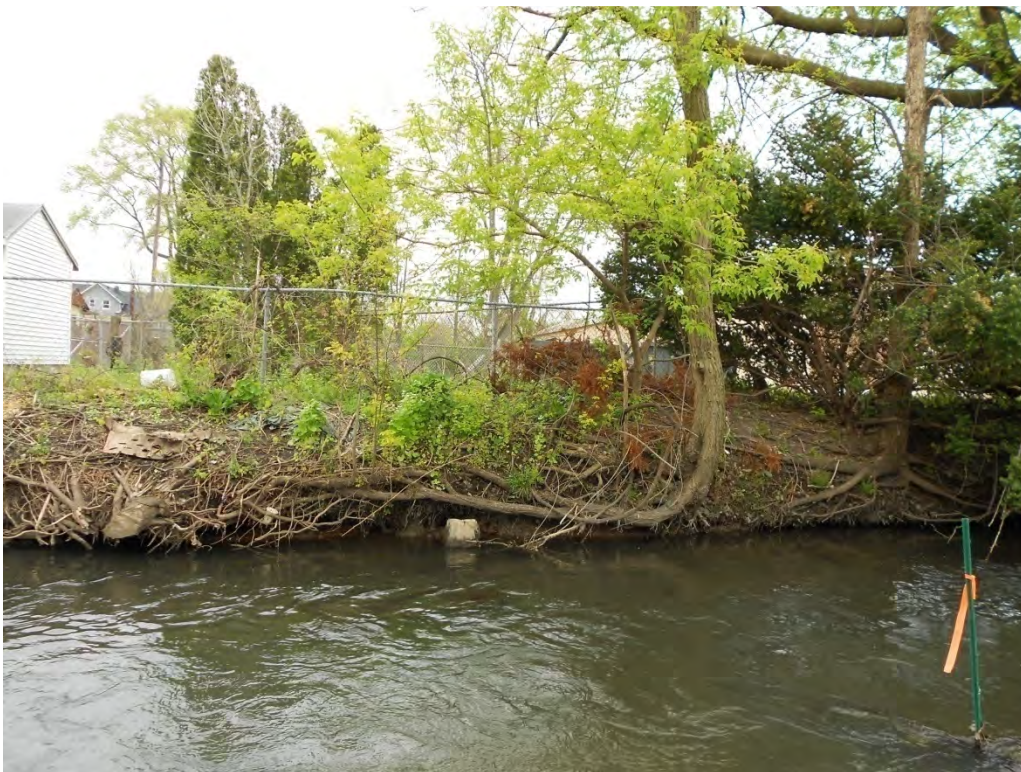
Bank erosion and undercutting along the property

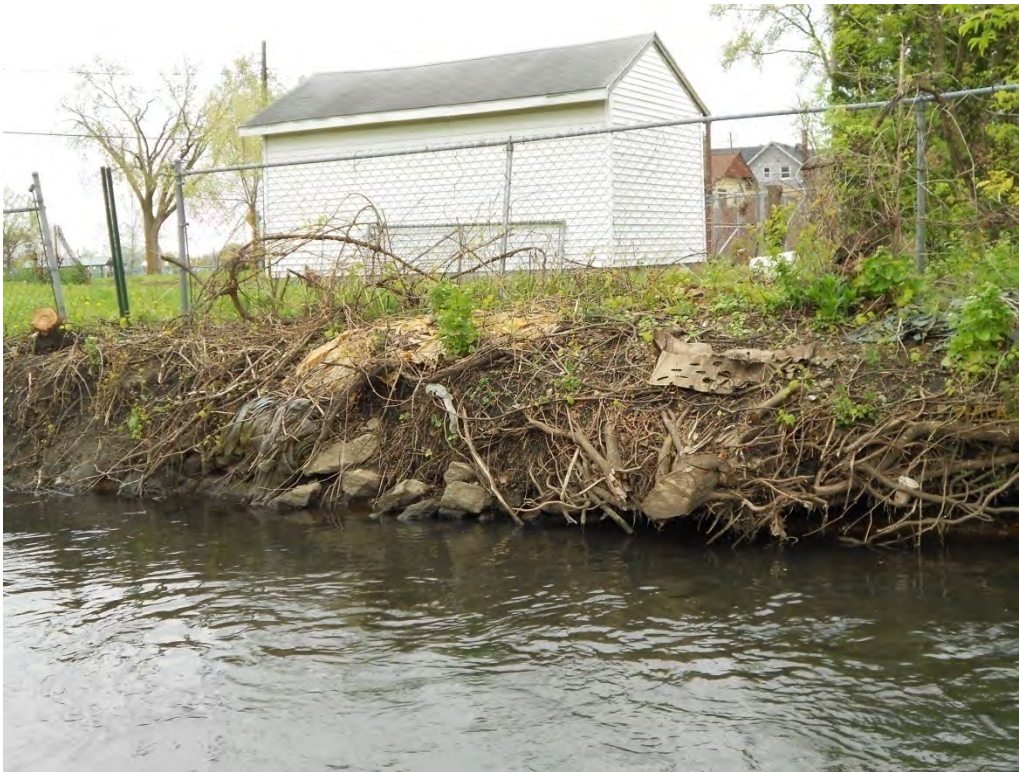
Bank erosion and undercutting along the property

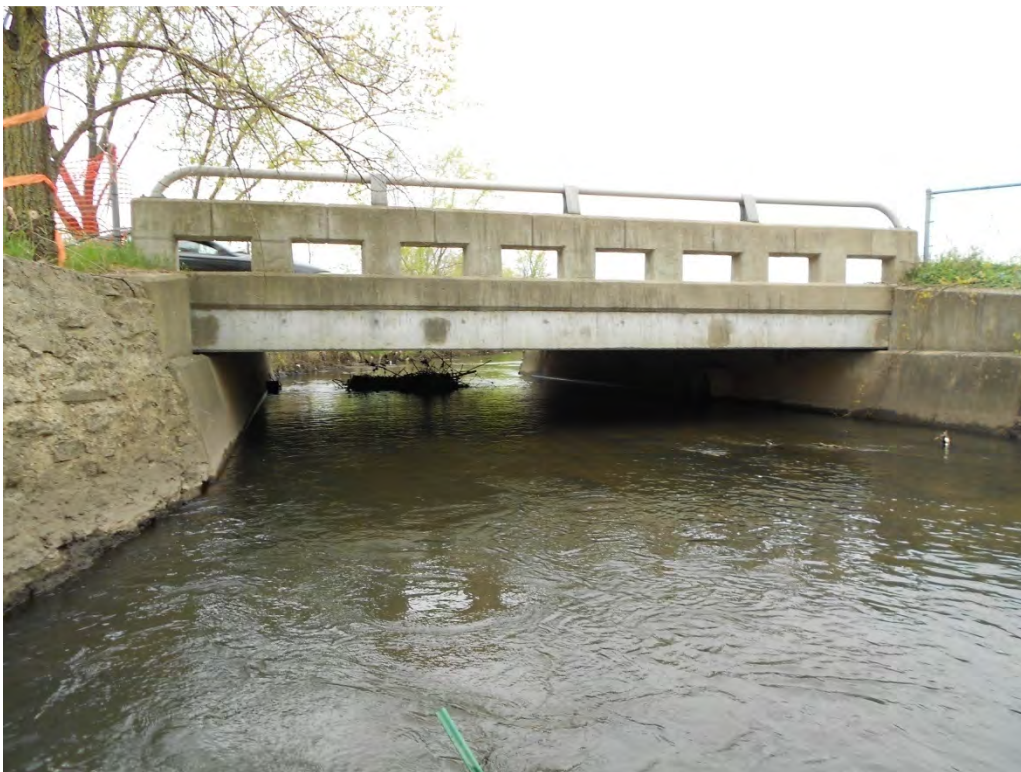
Elevation view of the structure from the upstream channel

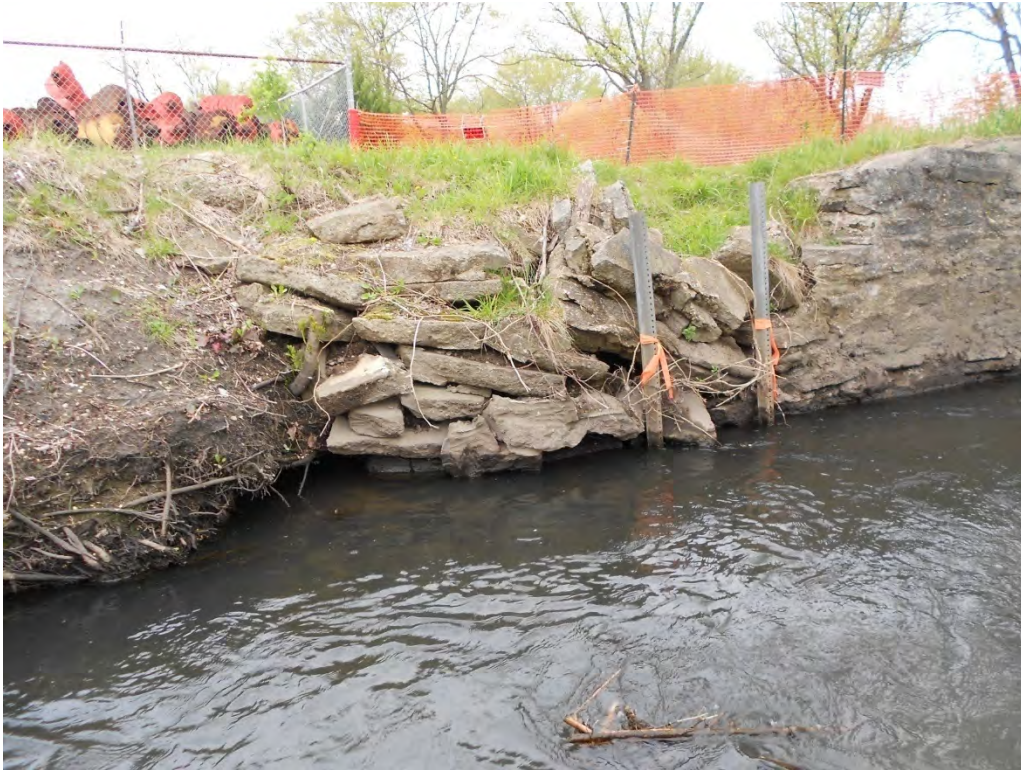
Concrete rubble wingwall extension in the southwest

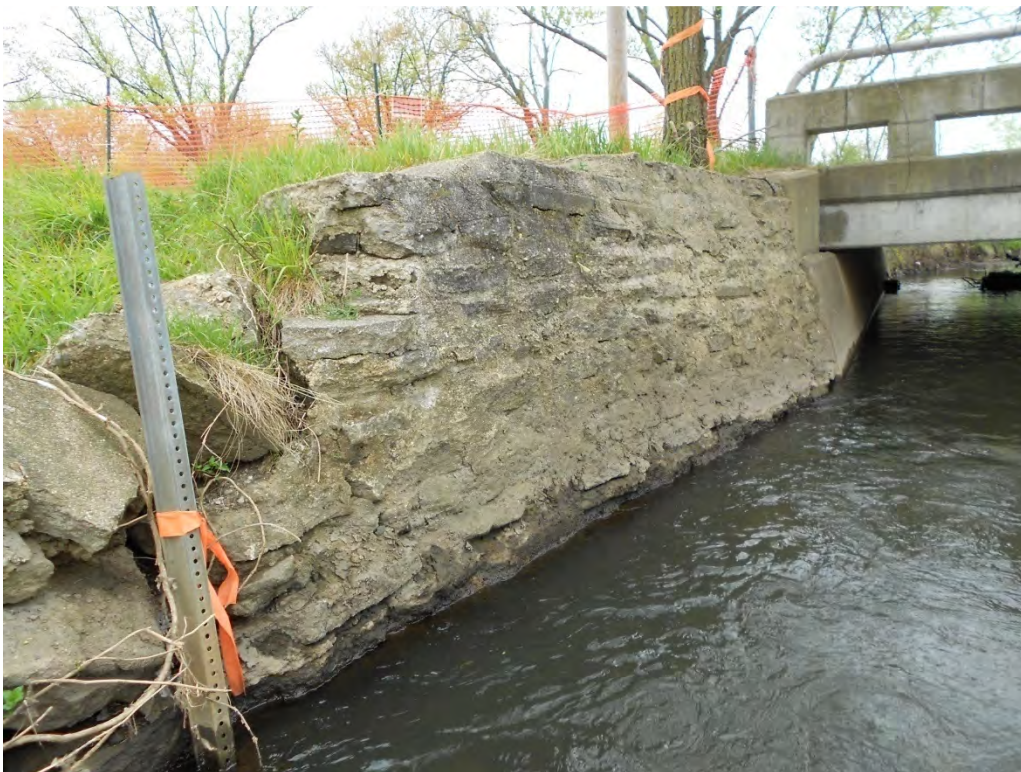
Concrete block wall in the southwest

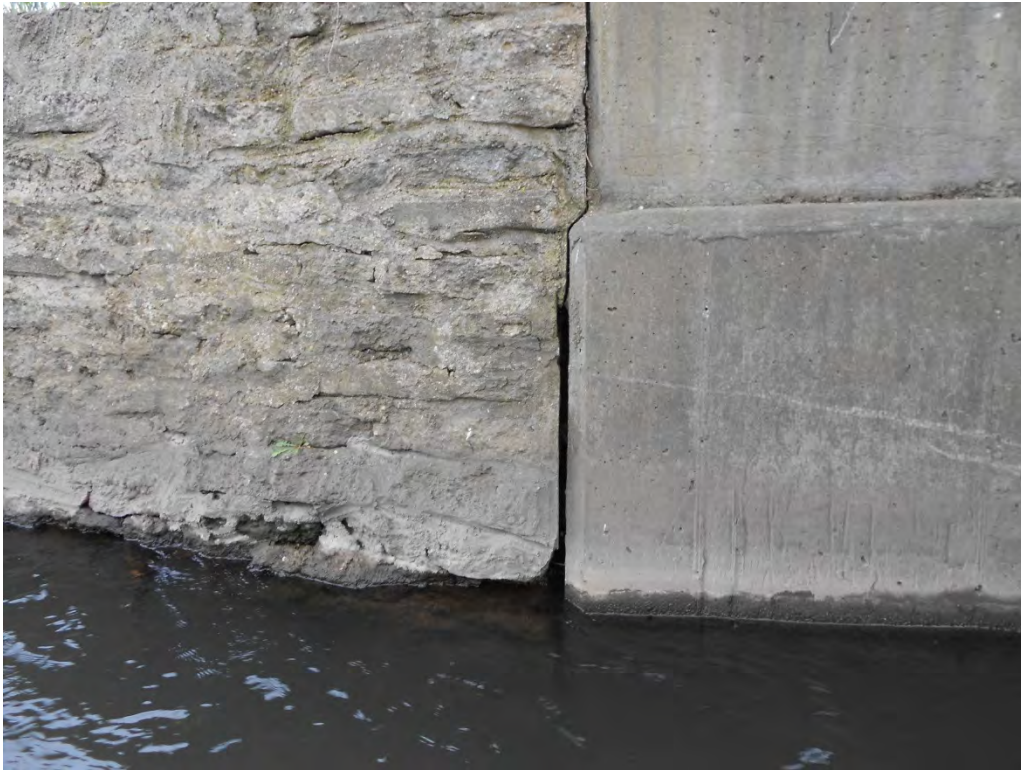
Gap between southwest concrete block wall and curtain wall

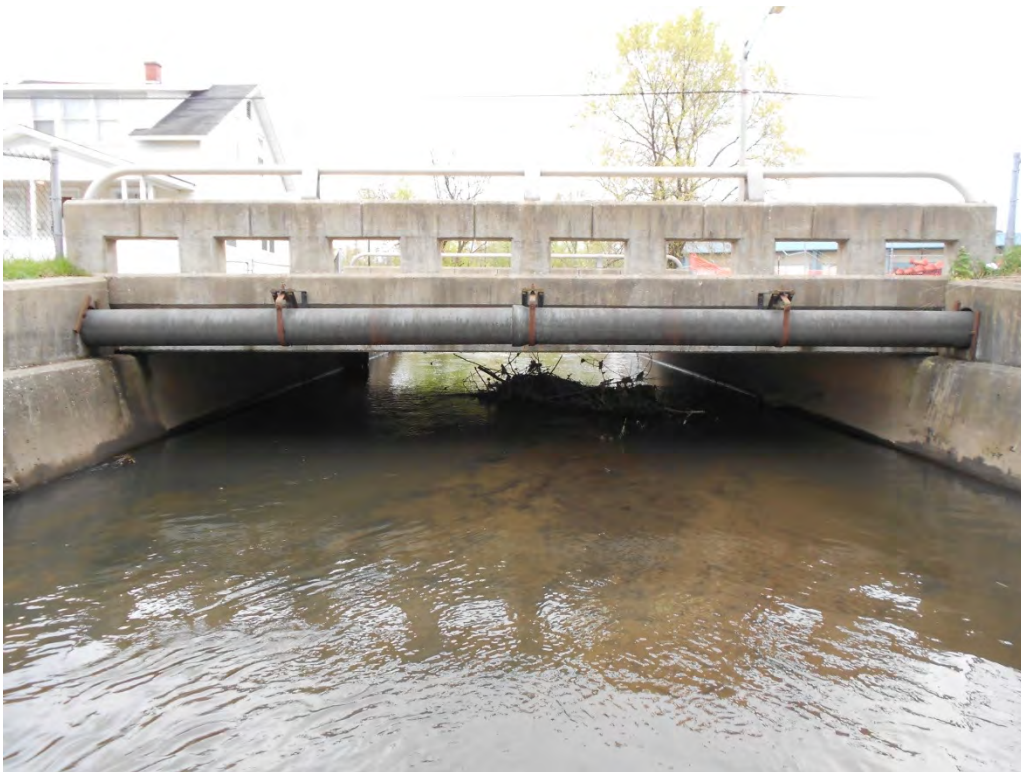
Water main along north fascia and debris pile under the structure

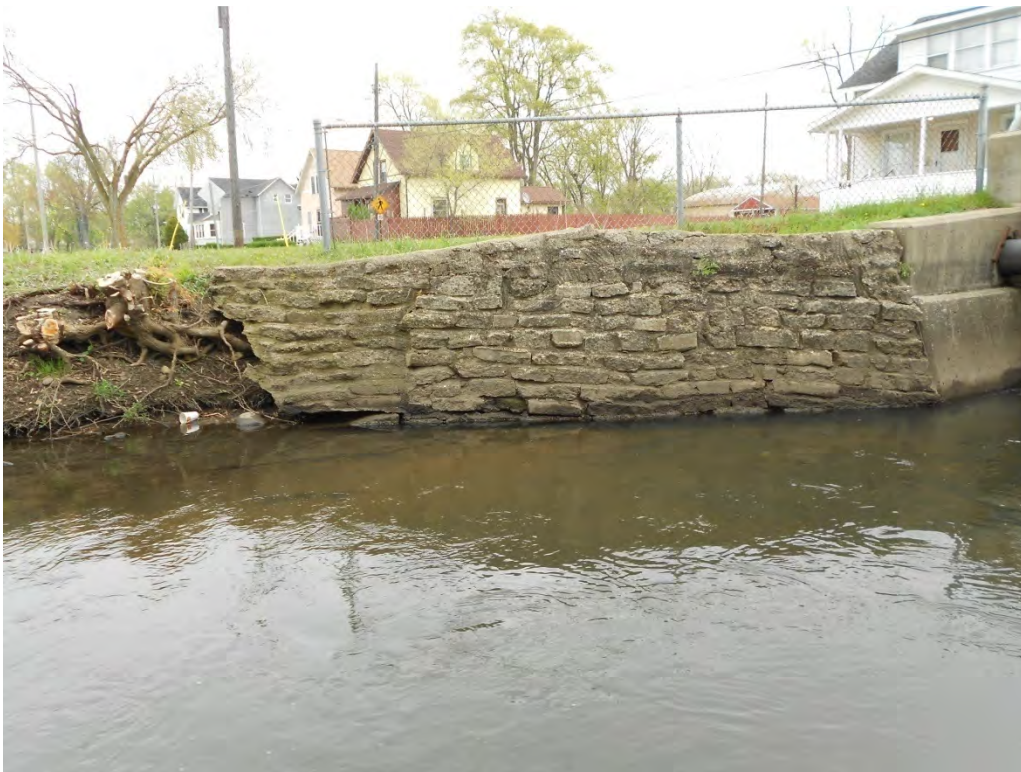
Overall view of the northeast concrete block wingwall

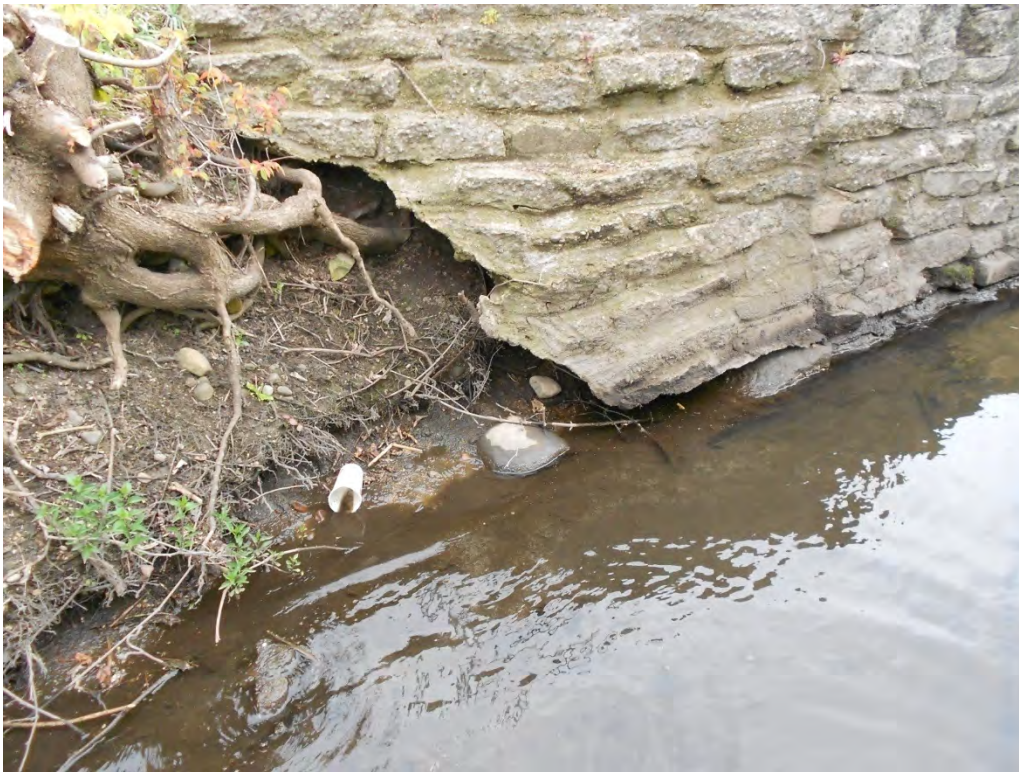
Bank erosion and undermining around the end of the northeast wingwall

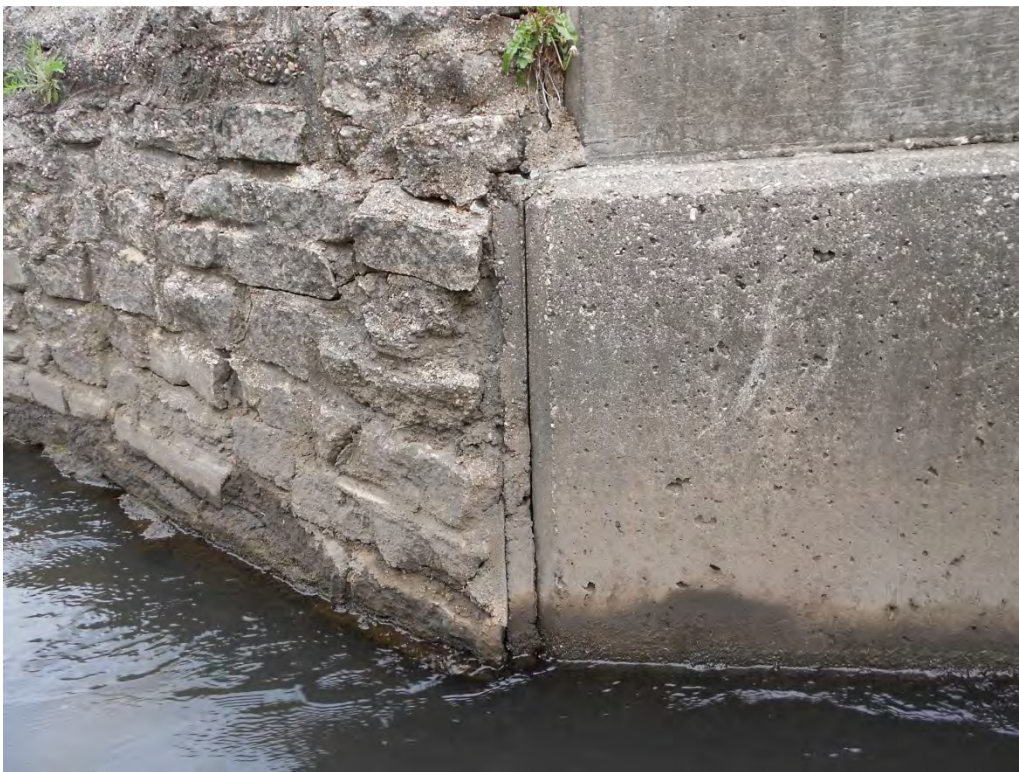
Sealed gap between the northeast wingwall and curtain wall

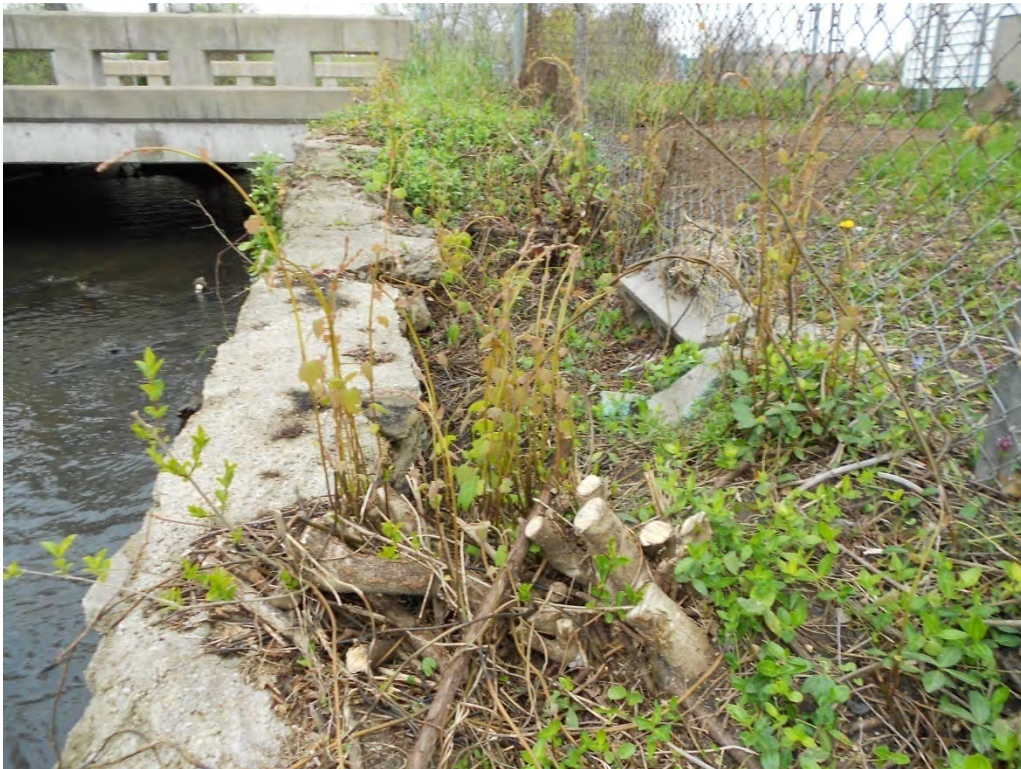
Loss of backfill behind the southeast wingwall
